***Report No. UT-03.34***

***FLEXURAL PERFORMANCE OF  
RETROFITTED REINFORCED  
CONCRETE CANTILEVERED  
BENT CAPS – PART 2***

**Utah Department of Transportation  
Research Division**

**December 2003**

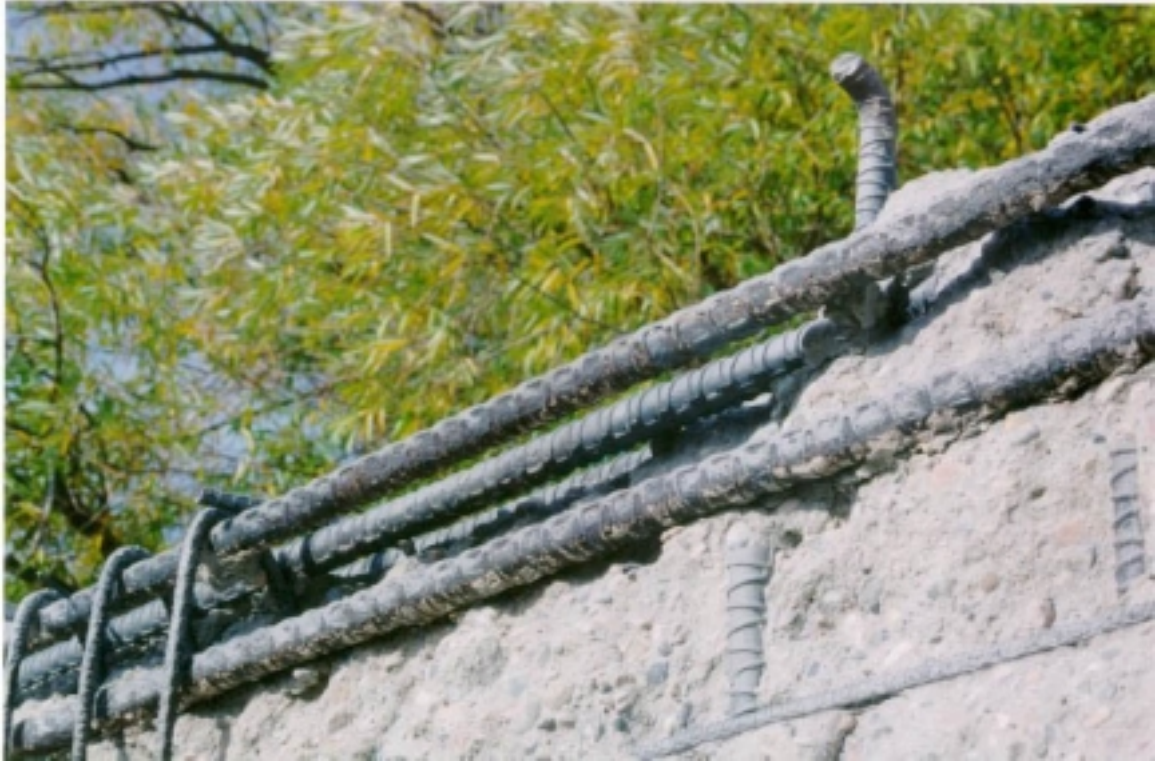
Figure 2.2 – East side of Bent 15N in pre-repair condition

The first step taken to repair Bent 15N was to chip away the unsound concrete around the exposed rebar with a jackhammer. Figure 2.2 shows the east side of the bent after the unsound concrete was removed and Figure 2.2a shows a detail of the longitudinal reinforcement. Figure 2.3 shows a schematic drawing of the exposed longitudinal reinforcement in the bent. Also shown is a top view of part of the bent. The percentage represents the approximate amount of longitudinal reinforcement remaining. The more that a section of rebar is exposed, the better the new concrete can encase the reinforcement. No more than about a quarter of an inch of space was between the exposed rebar and the “old” concrete. This 0.25 inch (6.35 mm) gap was determined, later on, not to be enough to make a good encasement of the “new” concrete around the reinforcement. After chipping away the unsound concrete, the bent was sand-blasted to remove any loose concrete and clean the reinforcement from any rust.

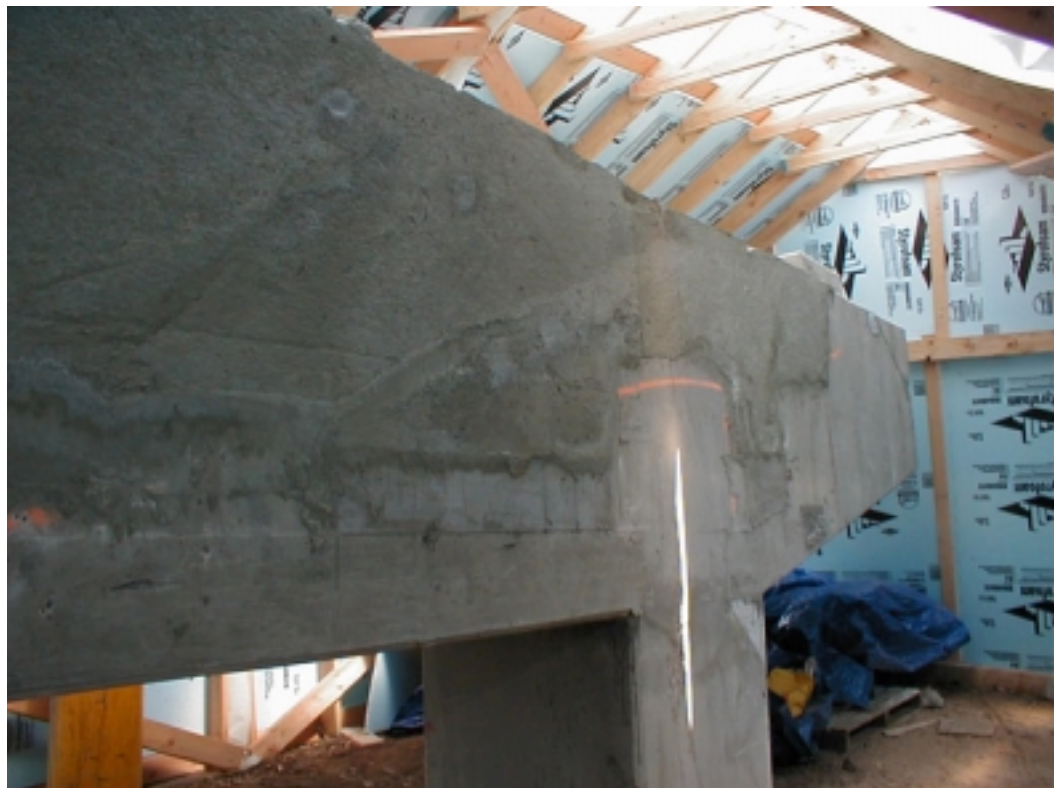
Figure 2.4 – Bent 15N with bottom portions patched

The bottom portions of the bent were coated with a bonding agent—Sika Armatec 110 EpoCem (see Appendix A). Forms were constructed around the bent, and the SikaRepair 222 concrete (see Appendix A) was poured. No aggregate was included in the concrete. Figure 2.4 shows the bent after its bottom portion had been patched. Due to weather conditions, a substantial length of time passed between the repairing of the bottom section and the rest of the bent. Slight rust formed on the exposed rebar during this time. Prior to repairing the rest of the bent, the rust was ground off the rebar.

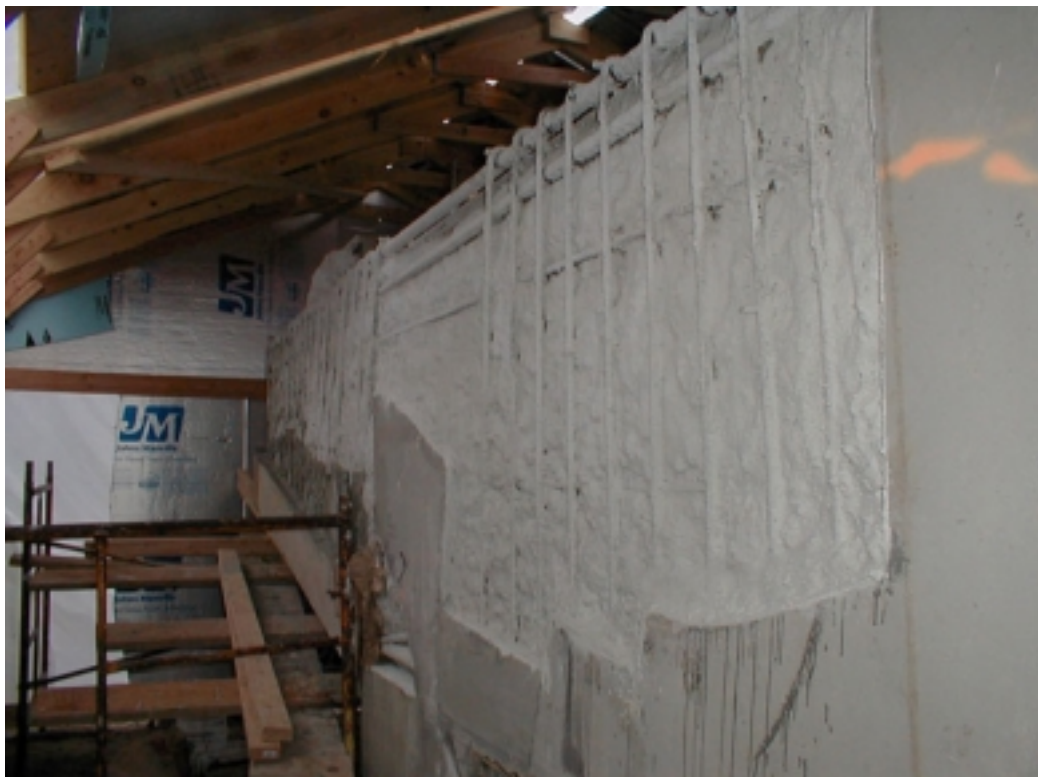
Figure 2.10 – Rebar on Bent 15S after removal of rust

As with Bent 15N, the rust was taken off the rebar with a grinder before any concrete was poured. Figure 2.10 shows the condition of the rebar after grinding. After the rust was removed, the exposed areas of the bent were coated with a bonding agent—to help the new concrete bond with the old. Forms were constructed around the bottom of the bent and the concrete was poured. Figure 2.11 shows Bent 15S after the forms had been installed and the bonding agent had been applied.

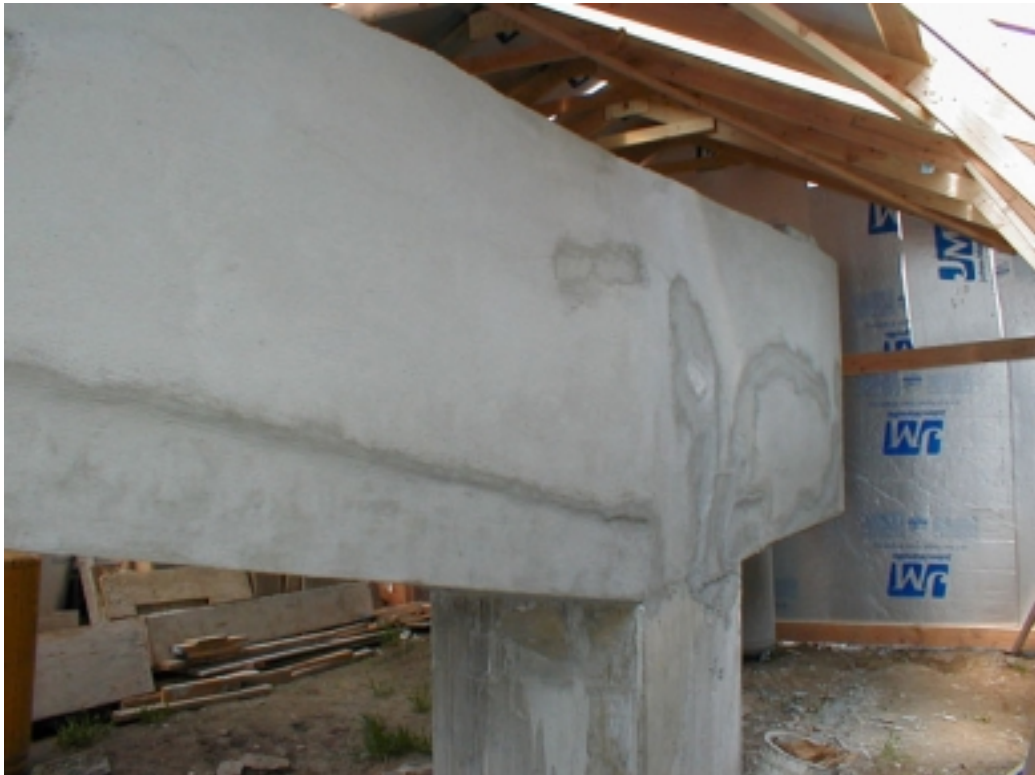
Figure 2.15 – Concrete forms on Bent 15S

Finally, forms were constructed around the sides of the bent as shown in Figure 2.15, and concrete was placed down the sides and on top of the bent. The fully repaired bent is shown Figures 2.16-2.18.

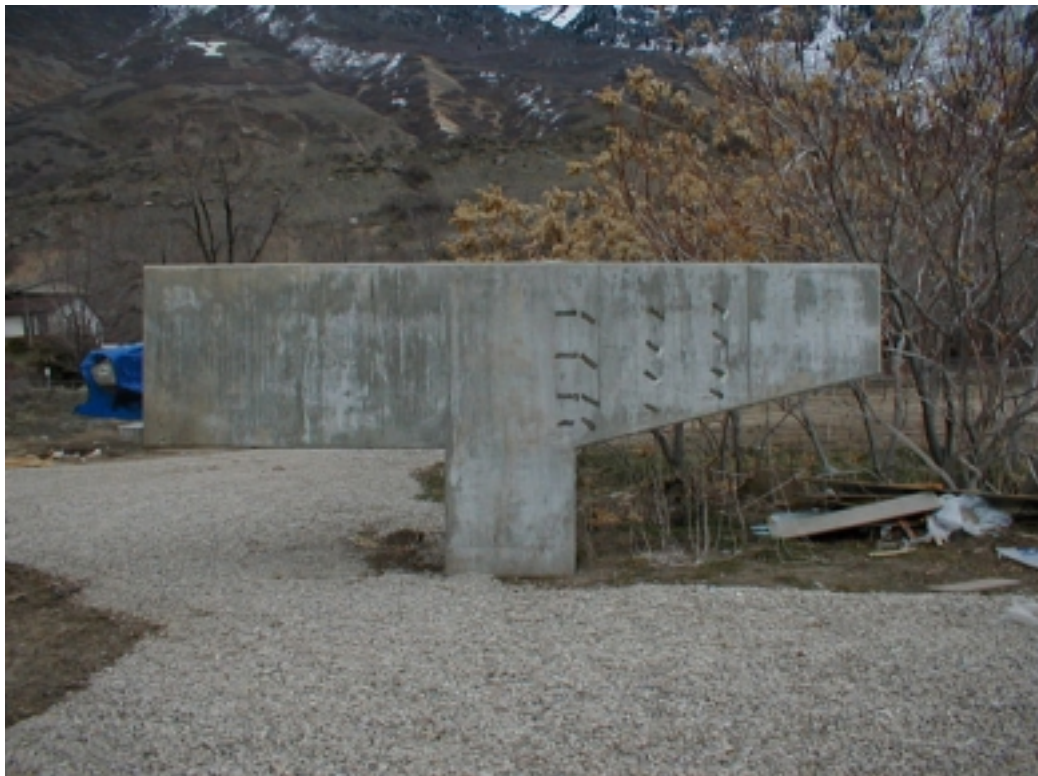
Figure 2.19 – Bent 15S before repair (cracks drawn on picture)

After the bent was repaired with the concrete patch, some pre-existing cracks in the West face of the bent, as shown in Figure 2.19, were epoxy injected. A full description of the epoxy injection method is discussed in section 2.2.1 of this report.

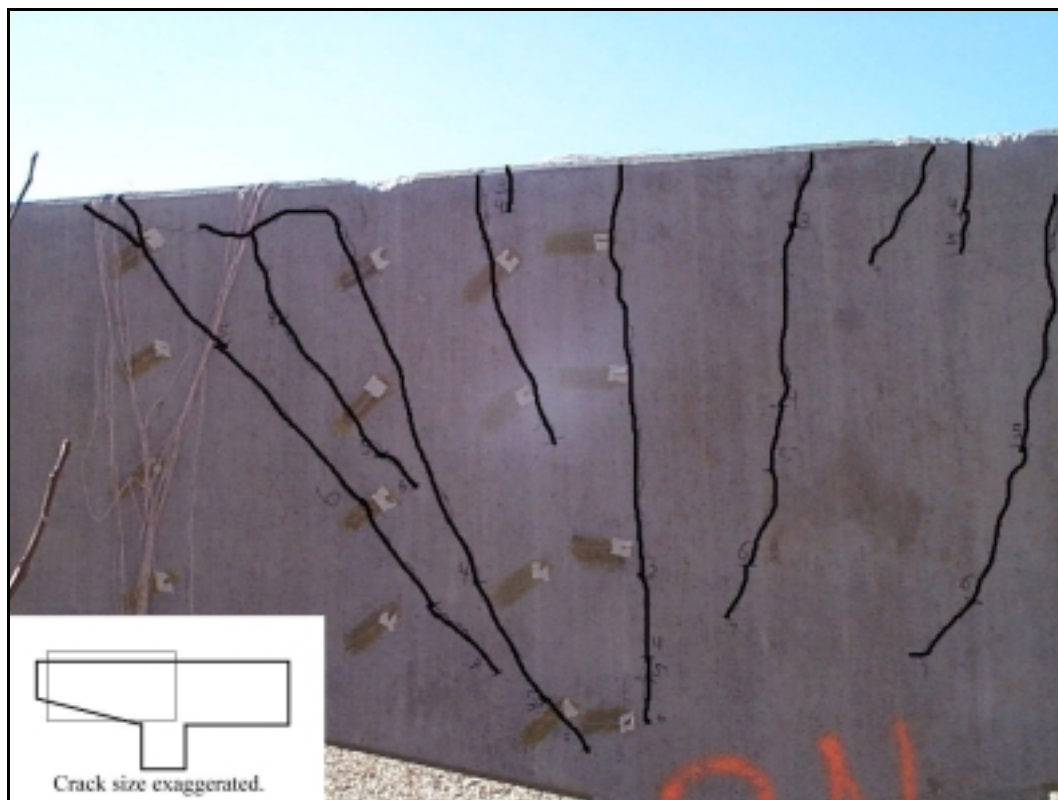
Figure 2.21 – West side of Bent 2N

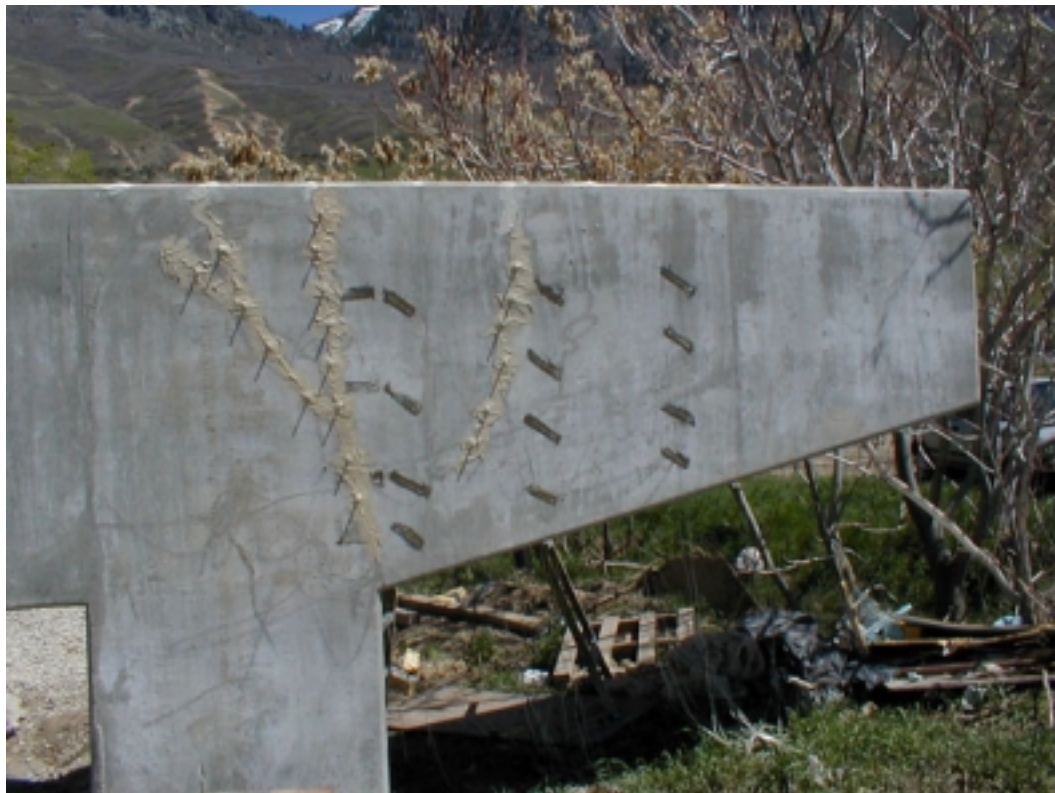
Figure 2.23 – Epoxy injection tubes and surface seal on Bent 2N

The first step in the epoxy injection method was to grind the concrete along the cracks. This was done to clean the surface along the cracks so that the cracks could be clearly seen. Next, small hollow tubes were inserted along the cracks about every 6 to 18 inches (152-457 mm). After the tubes were in place, the cracks were sealed so as to prevent leaking out of the epoxy at the surface during epoxy injection. The epoxy was then injected into the cracks through these hollow tubes. Figure 2.23 shows the hollow tubes and surface seal along a crack. Finally the epoxy was injected into the cracks through the tubes. Tyfo 103 Regular Injection Epoxy (see Appendix A for material specifications and properties) was used.

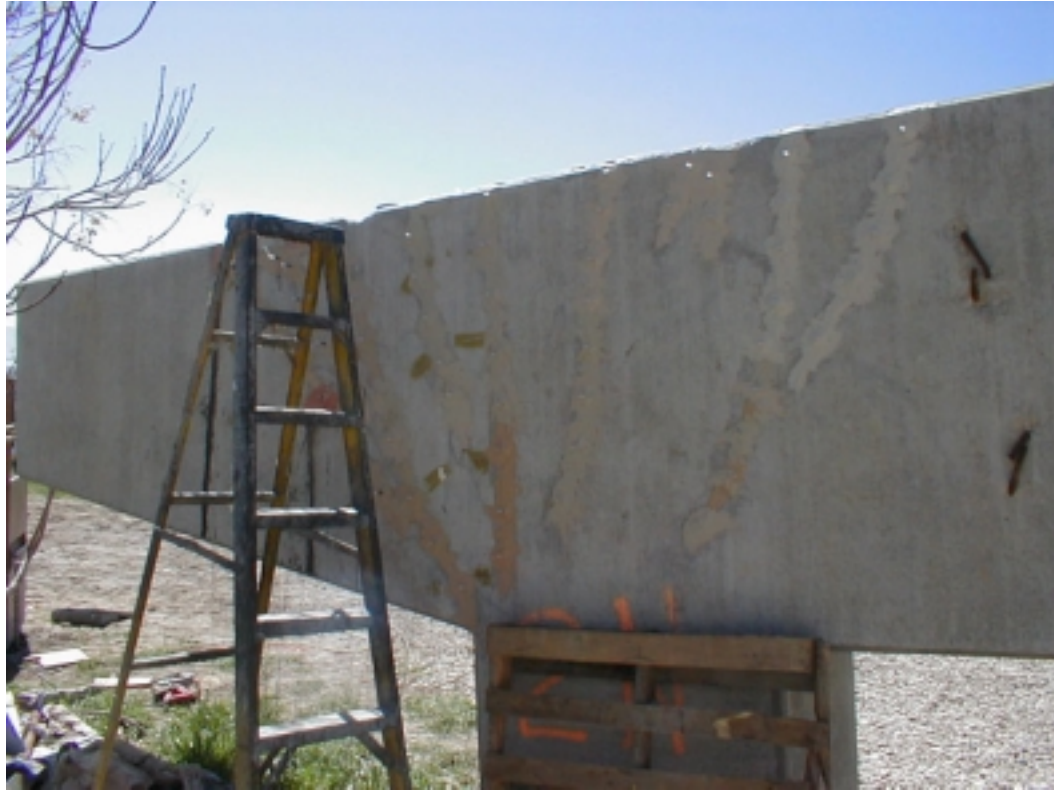
Figure 2.24 – Location of epoxy injected cracks on east side of Bent 2N

After the epoxy had time to cure, which took approximately two days, the surface seal and tubes were ground off so that there was a smooth surface on the bent. Figure 2.24 shows the array of plastic tubes along the cracks on the East face and Figure 2.25 shows the cracks after the grinding of the surface.

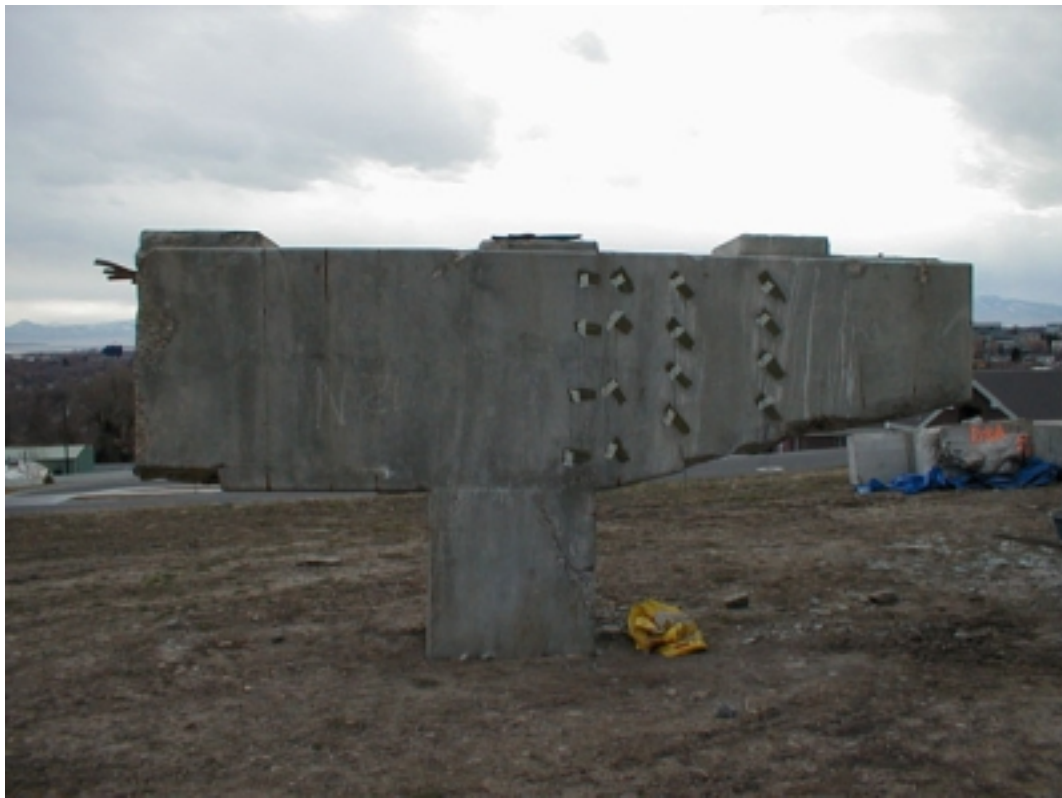
Figure 2.25 – Location of epoxy injected cracks on West side of Bent 2N

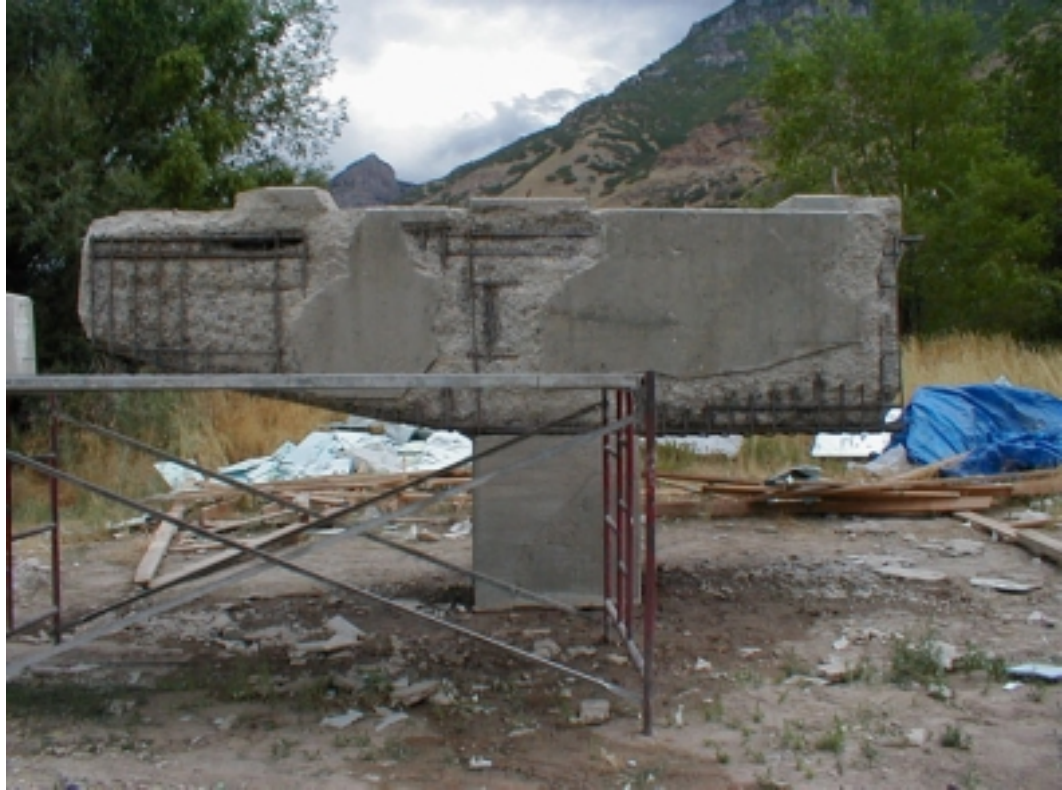
Figure 2.34 – Condition of Bent 13S after concrete was chipped away

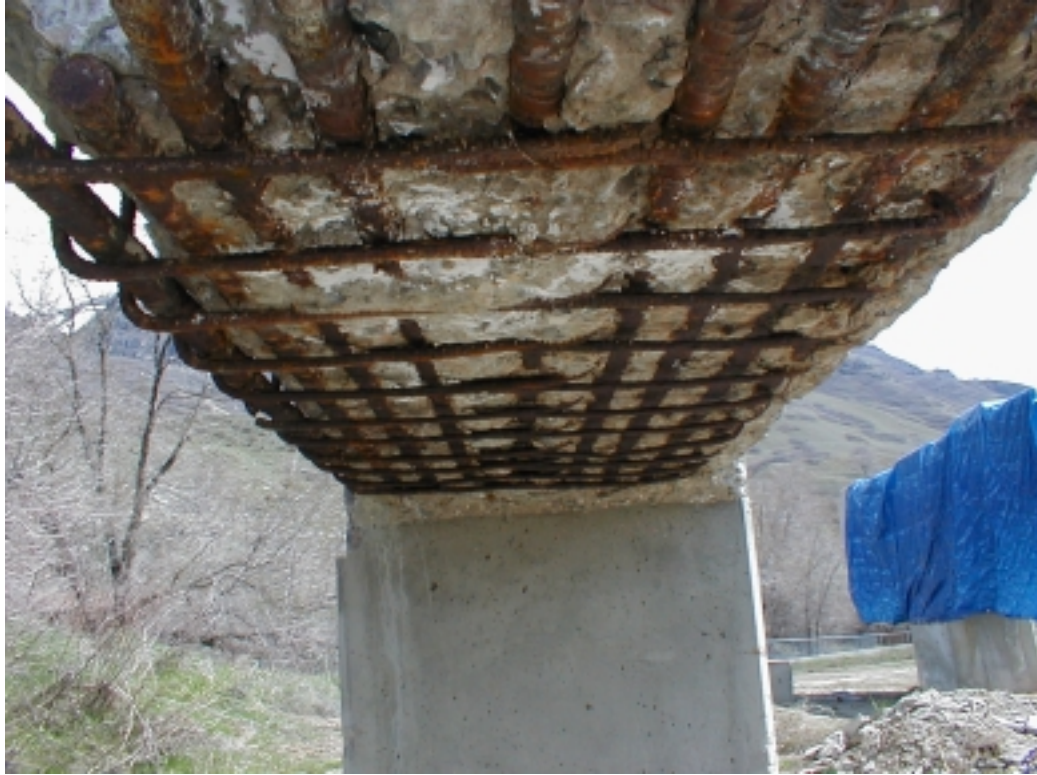
Figure 2.48 – East face of Bent 13N before repair

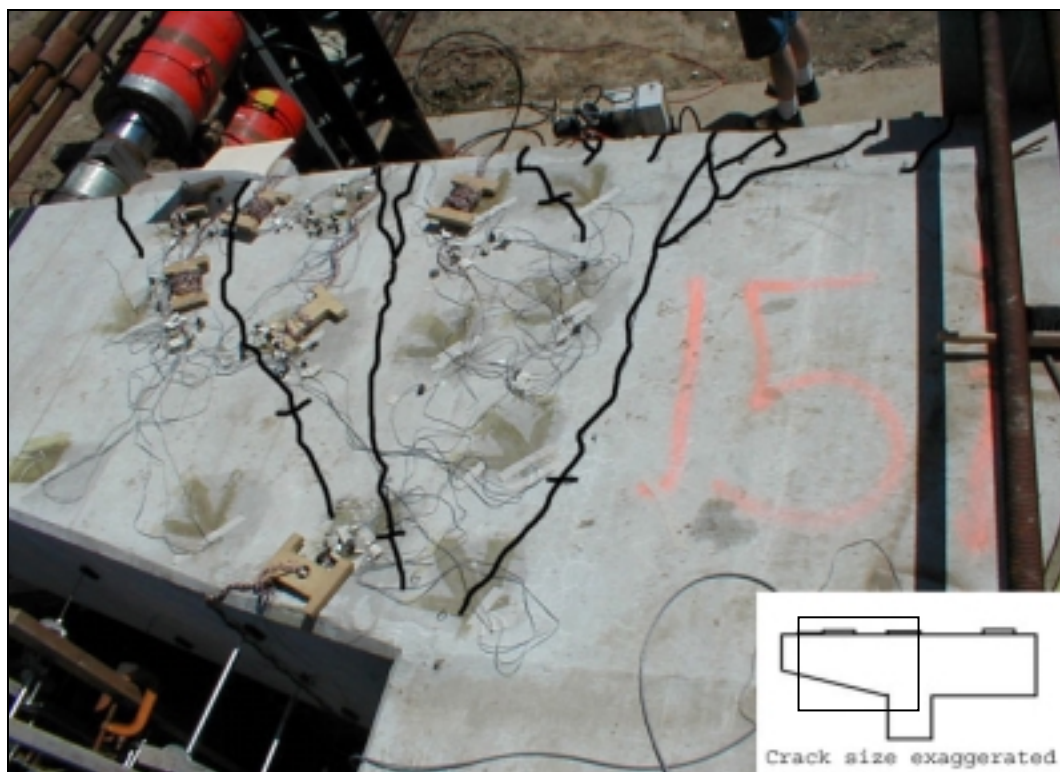
Figure 4.12 – Further propagation of cracks, cycle 5

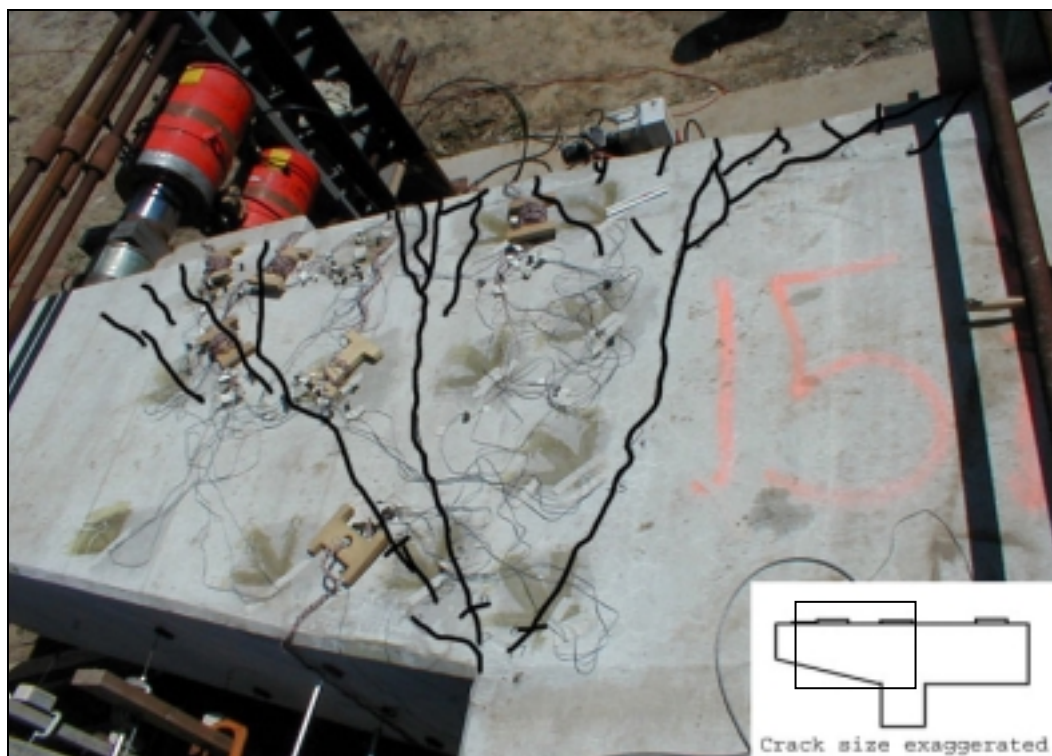
Figure 4.13 – Further propagation of cracks, cycle 6

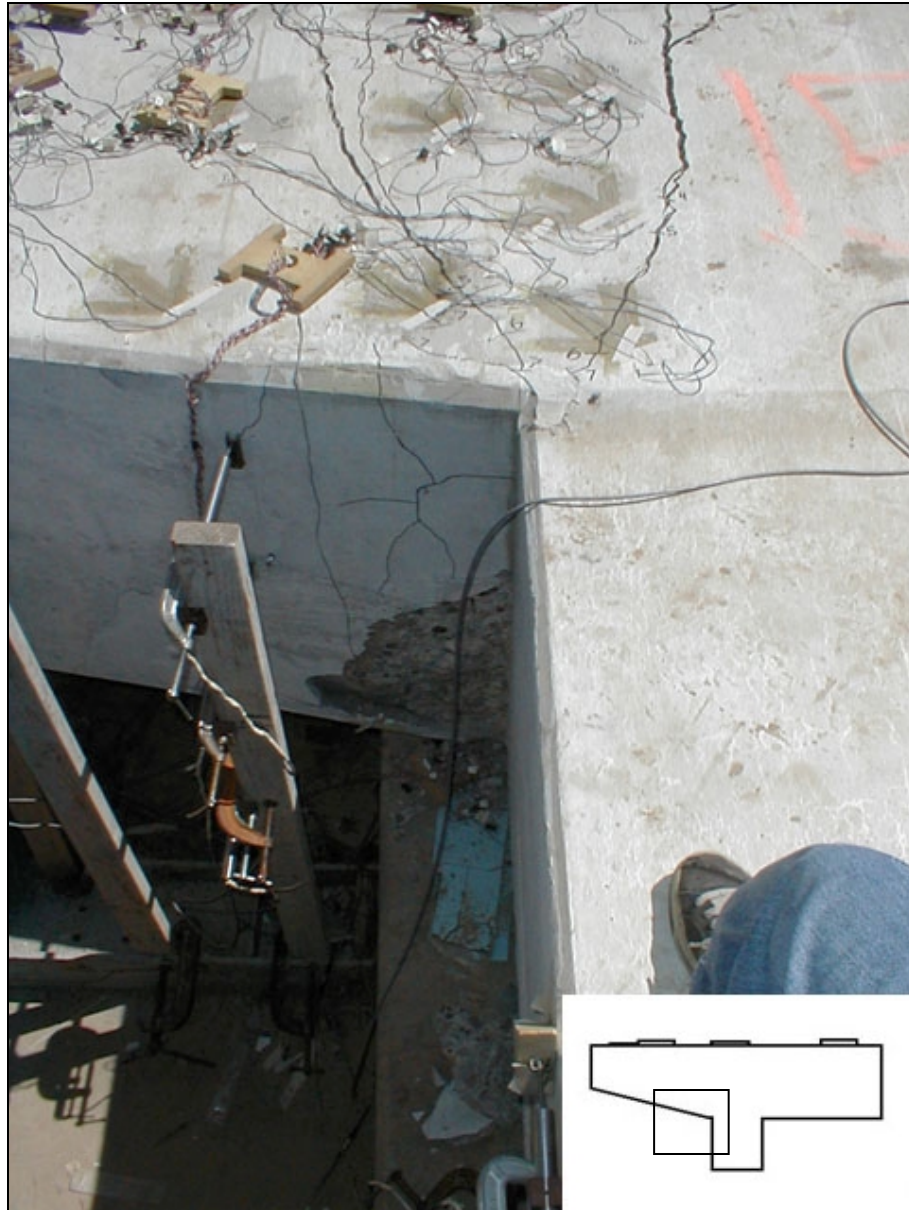
Figure 4.14 – New cracks formed on Bent 15N, cycle 7

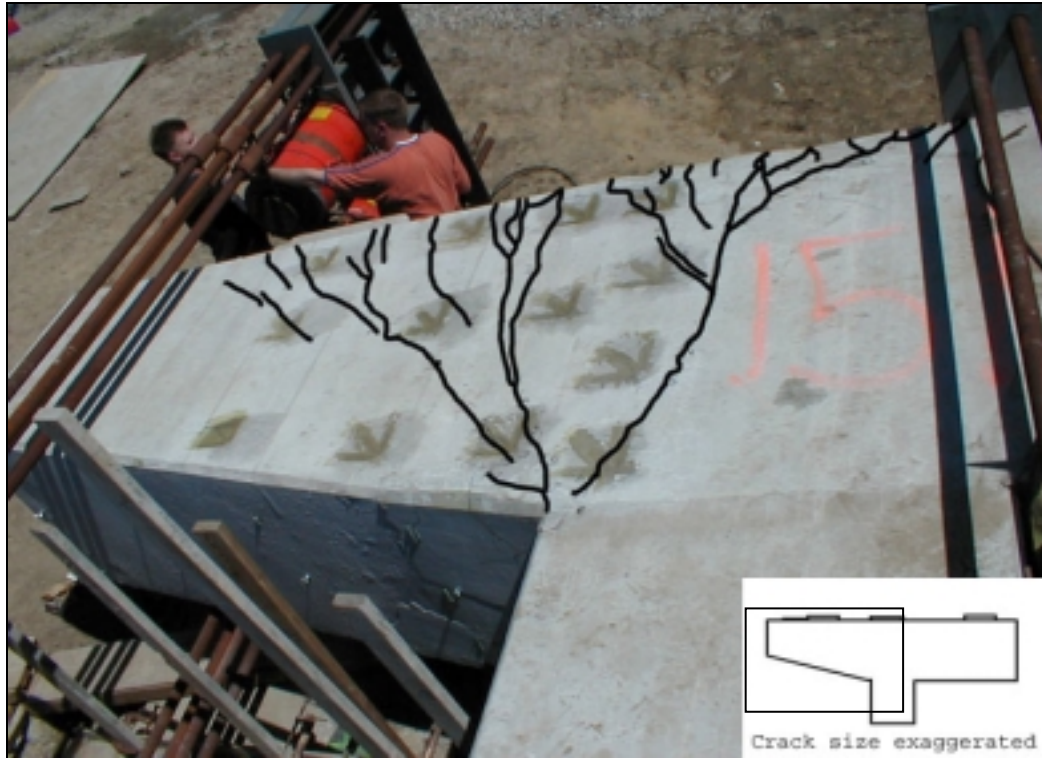
Figure 4.15 – Crushing and spalling of concrete in compression zone of Bent 15N

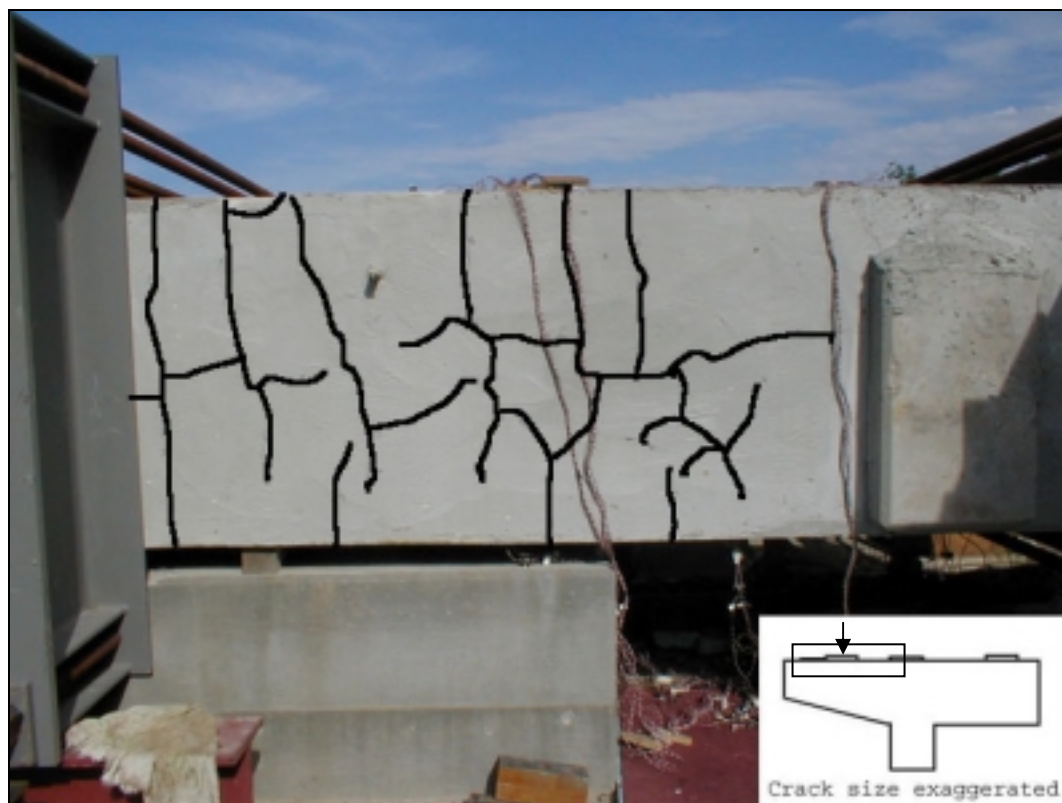
Figure 4.18 – Cracks of approximately 0.5 in (13 mm), cycle 7, Bent 15N

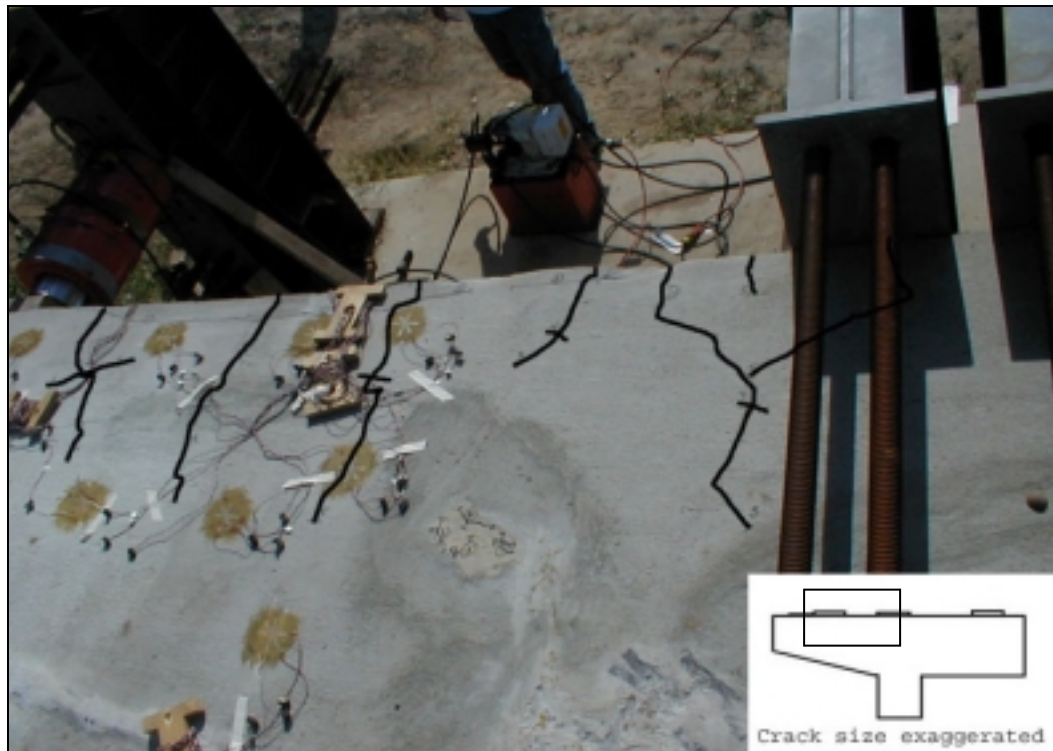
Figure 4.23 – Bent 15S, initiation of cracks, cycle 4

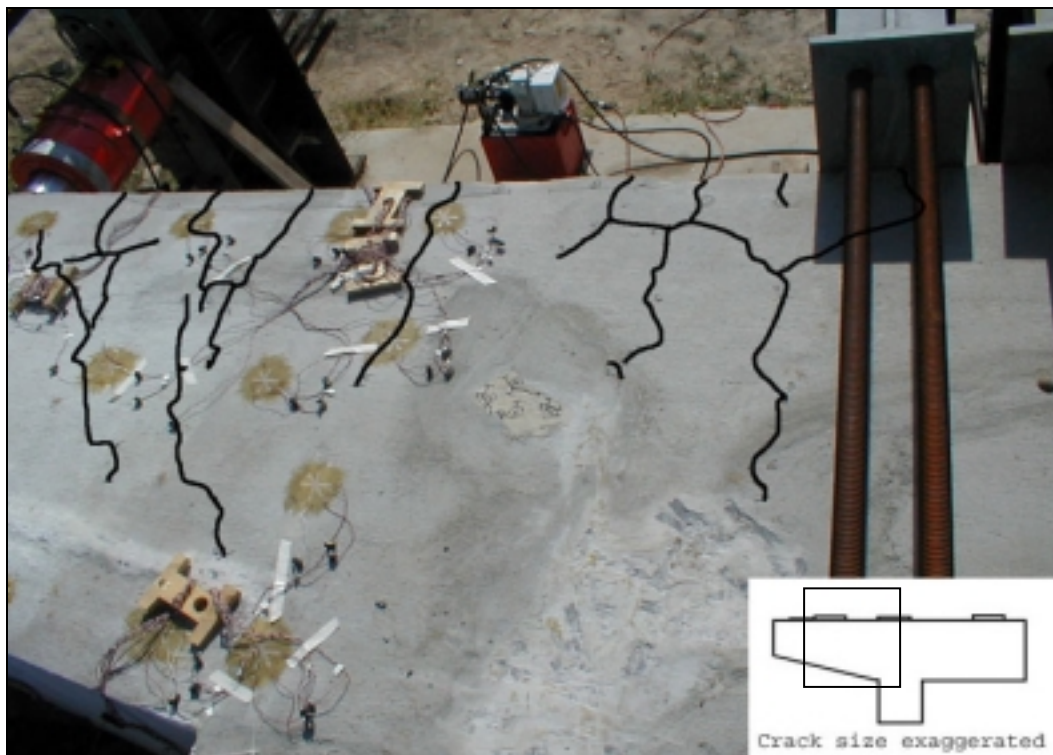
Figure 4.24 – Propagation of cracks, cycle 5, Bent 15S

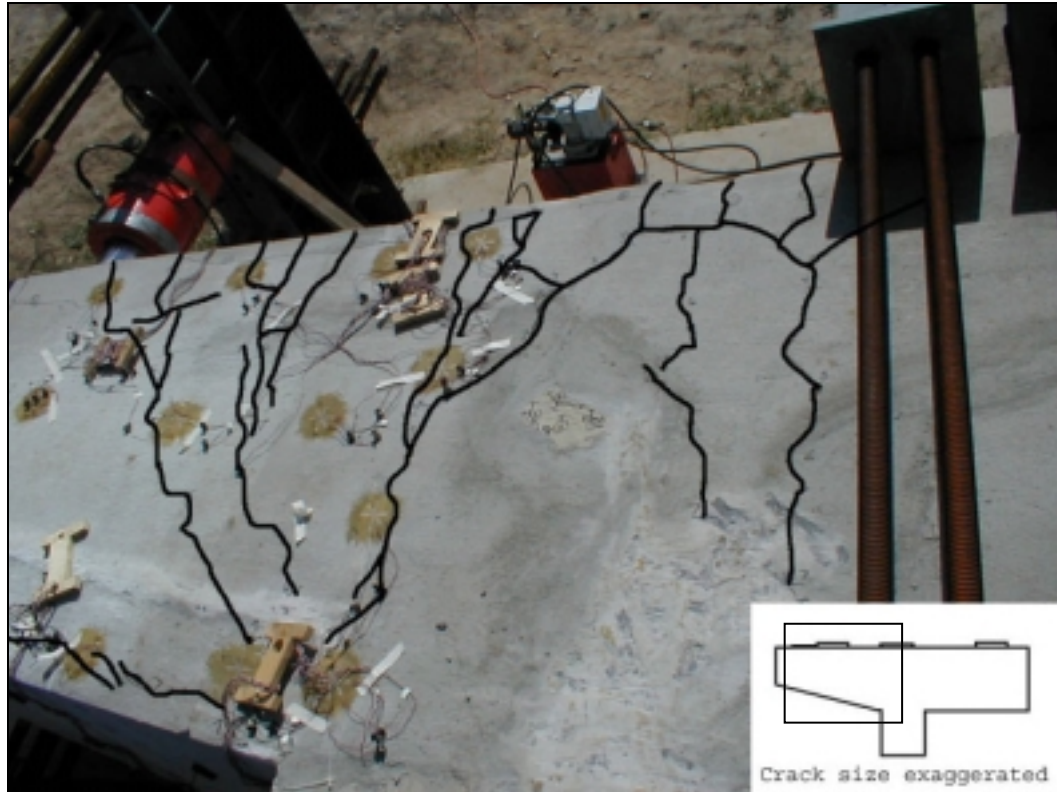
Figure 4.25 – Further propagation of cracks, cycle 6, Bent 15S

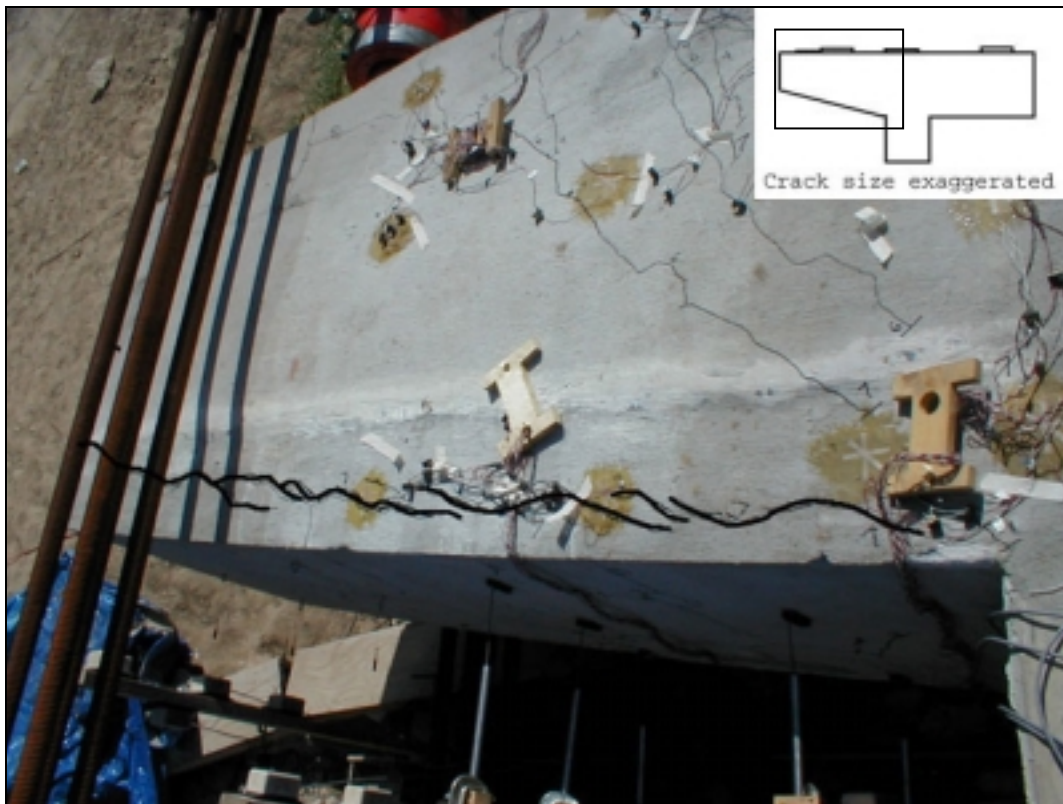
Figure 4.28 – Crack width of approximately 0.375 in (10 mm), cycle 7, Bent 15S

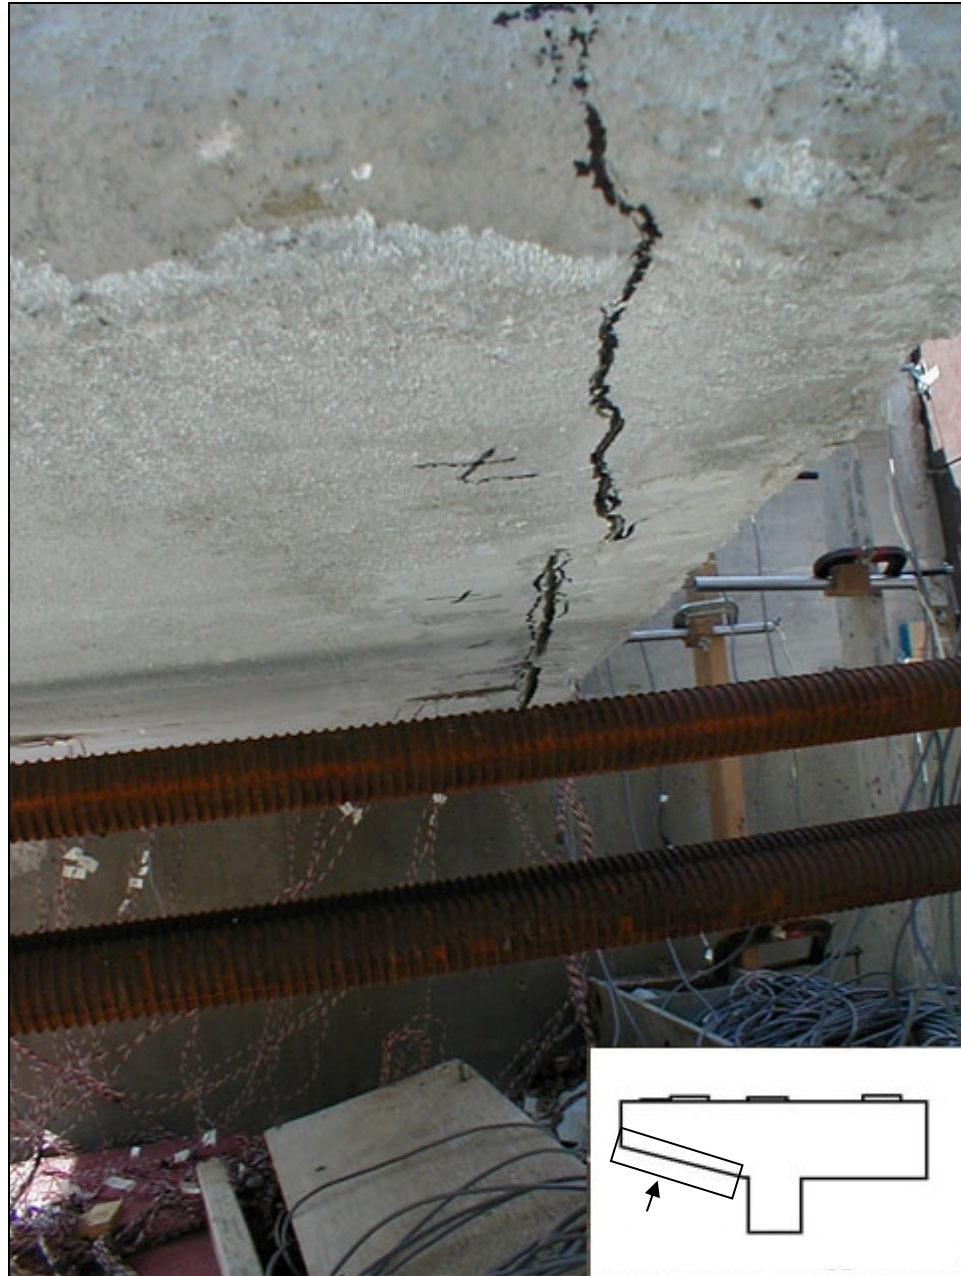
Figure 4.29 – Cracks along new and old concrete interface, west face, cycle 7

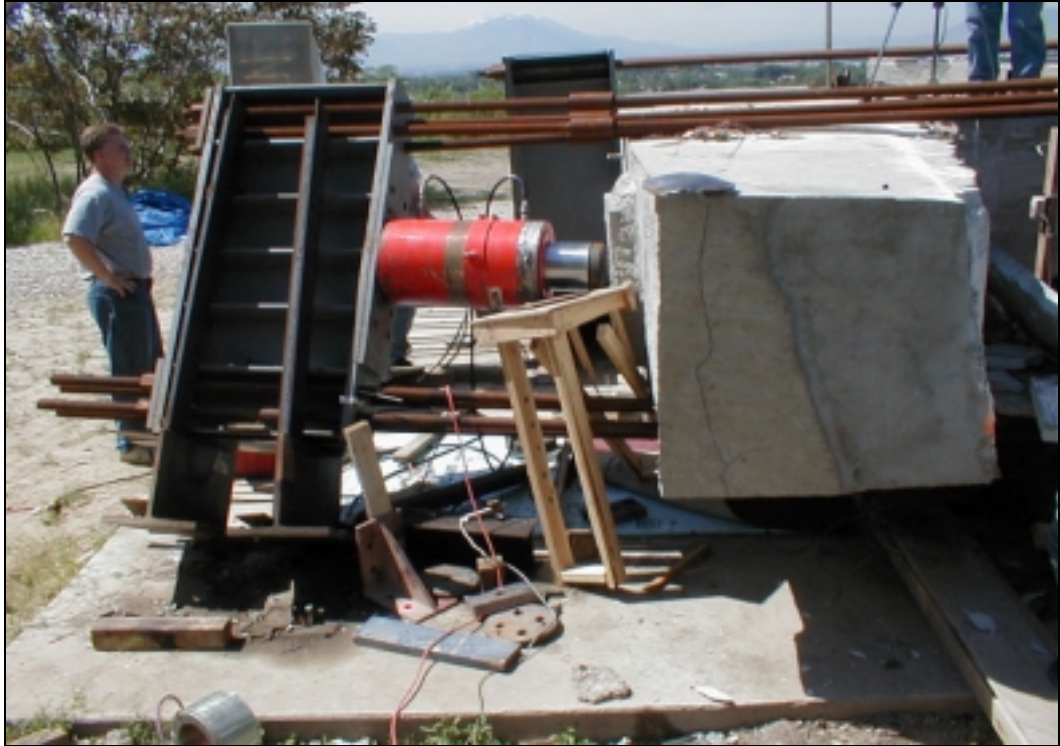
Figure 4.36 – Failure of the Loading Frame—Back View

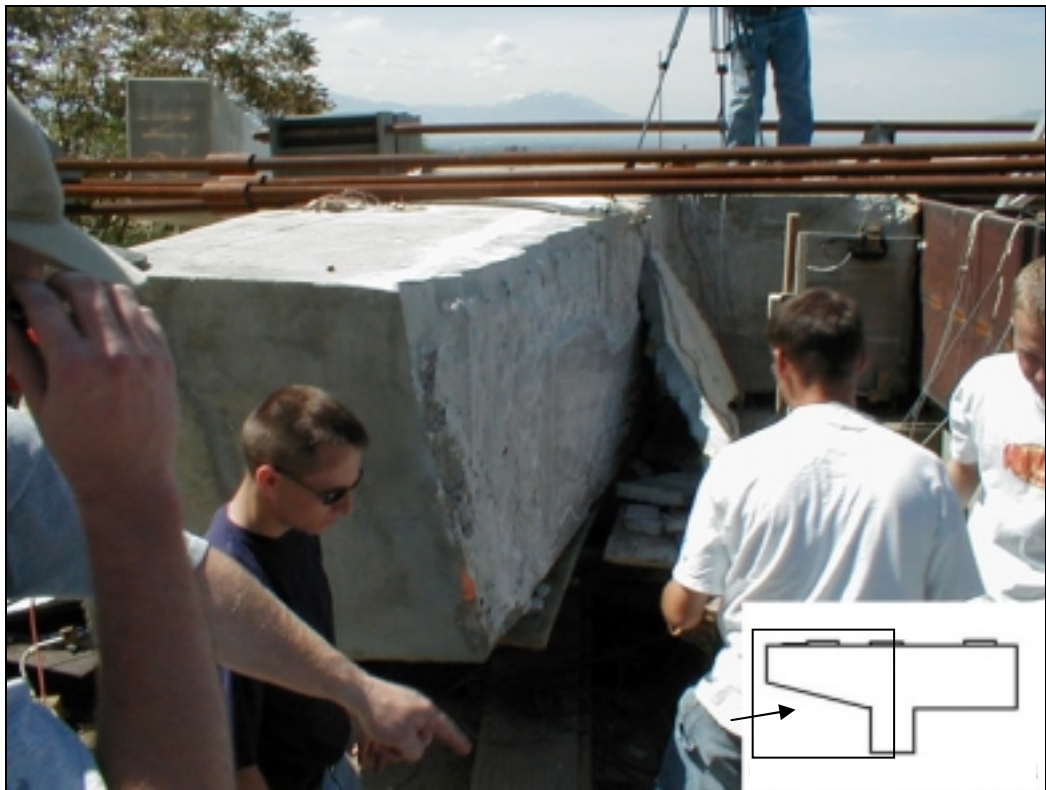
Figure 4.37 – Failure of the Loading Frame—Side View

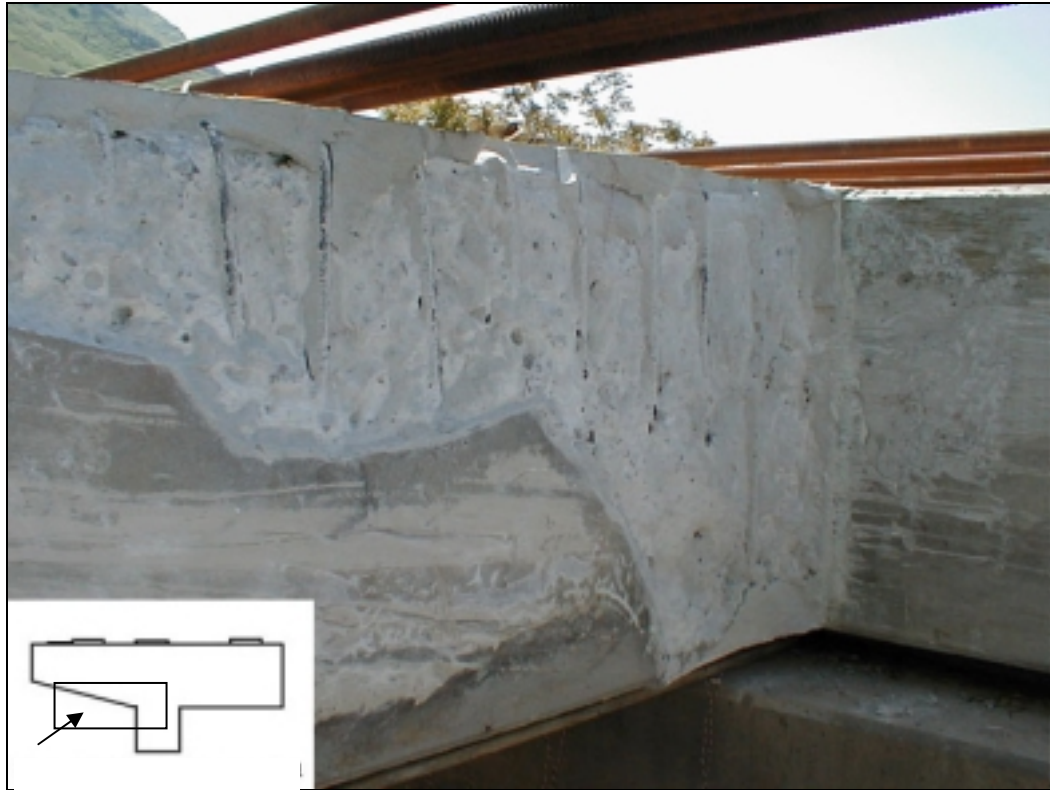
Figure 4.38 – Failure of the concrete patch

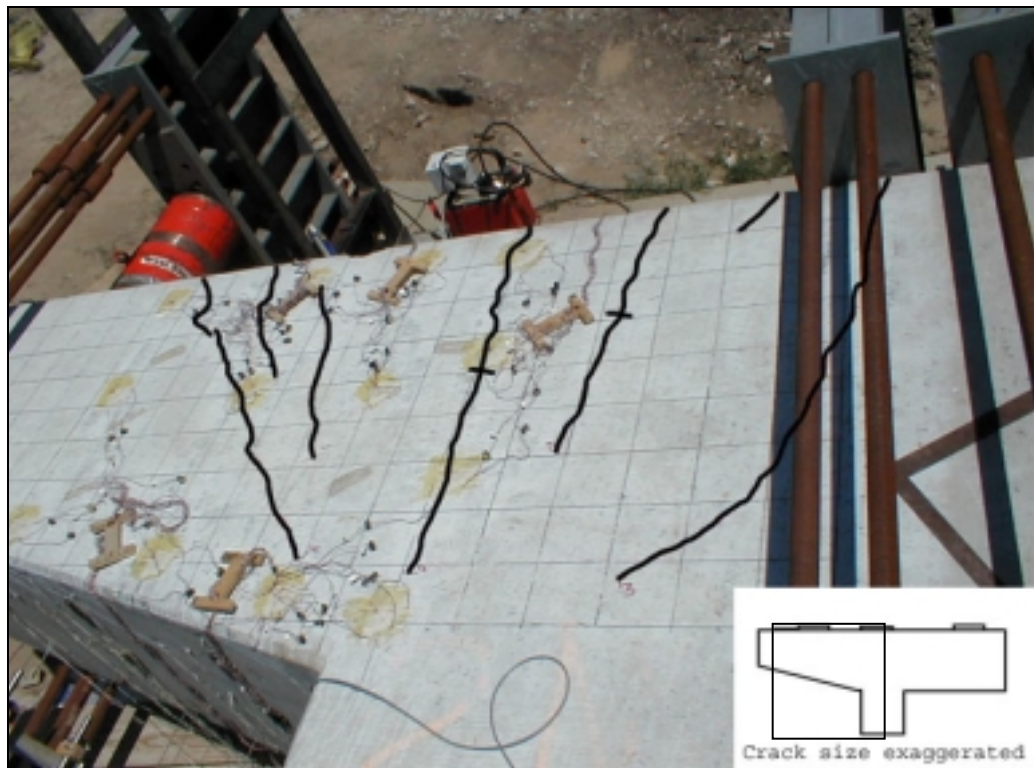
Figure 4.45 – Bent 2N, cracks on cycle 2
